# **Field Report for Airborne Data Collected In Support of US EPA Region 6 South 4 Group Fire 04 December 2019**

The US EPA Region 6 requested that the ASPECT system be deployed to provide monitoring support beginning on 27 November 2019. This report summarizes findings observed during the two missions flown on 04 December 2019.

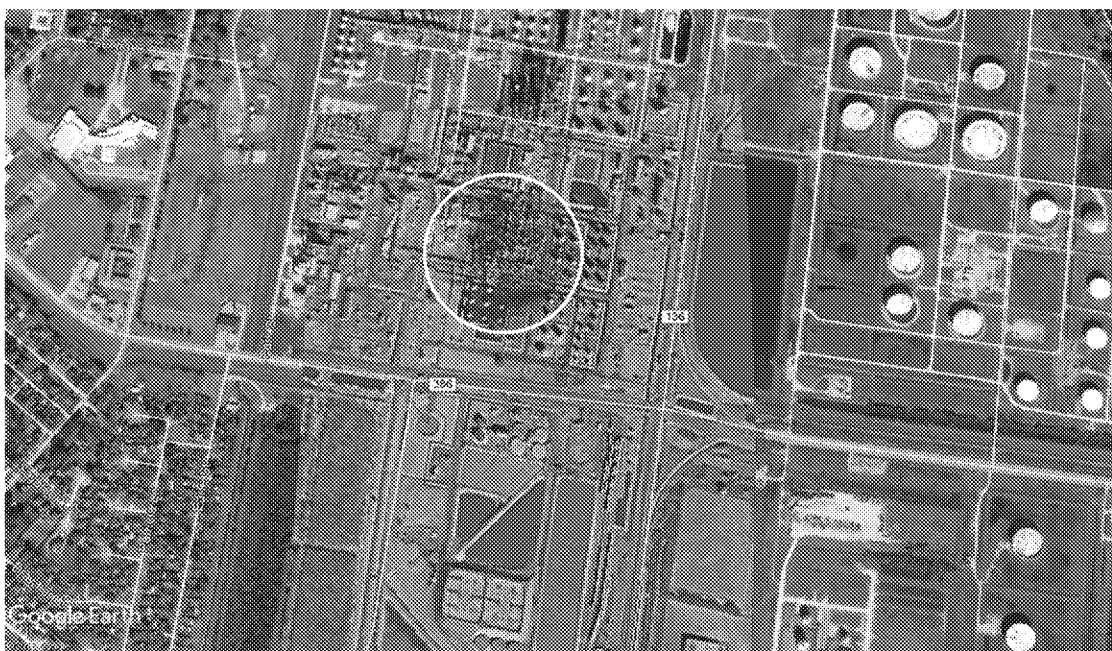
Figure 3: – 3 band IR image, Flight 14, Run 8, South 4 Group Fire

A total of 1 test and 8 data collection passes were made in the proximity of the fire and an infrared line scanner image was generated for each pass. Figure 3 shows a typical 3-band infrared image obtained from data collected for Run 2. The thermal environment of the unit continues to be low. At the time of the IR collection, a water cannon was being used to spray a spherical tank south of the production unit, but no water was being applied to the unit proper. No emissions were detected in the IR imagery. Figure 4 shows a close-up thermal analysis of the production facility. Solar heating of tanks and metal surfaces is evident in the image. A cool spray of water can be seen being directed to a spherical tank south of the unit with that tank much cooler than the neighboring vessels. No significantly elevated temperature sources are present in the image.

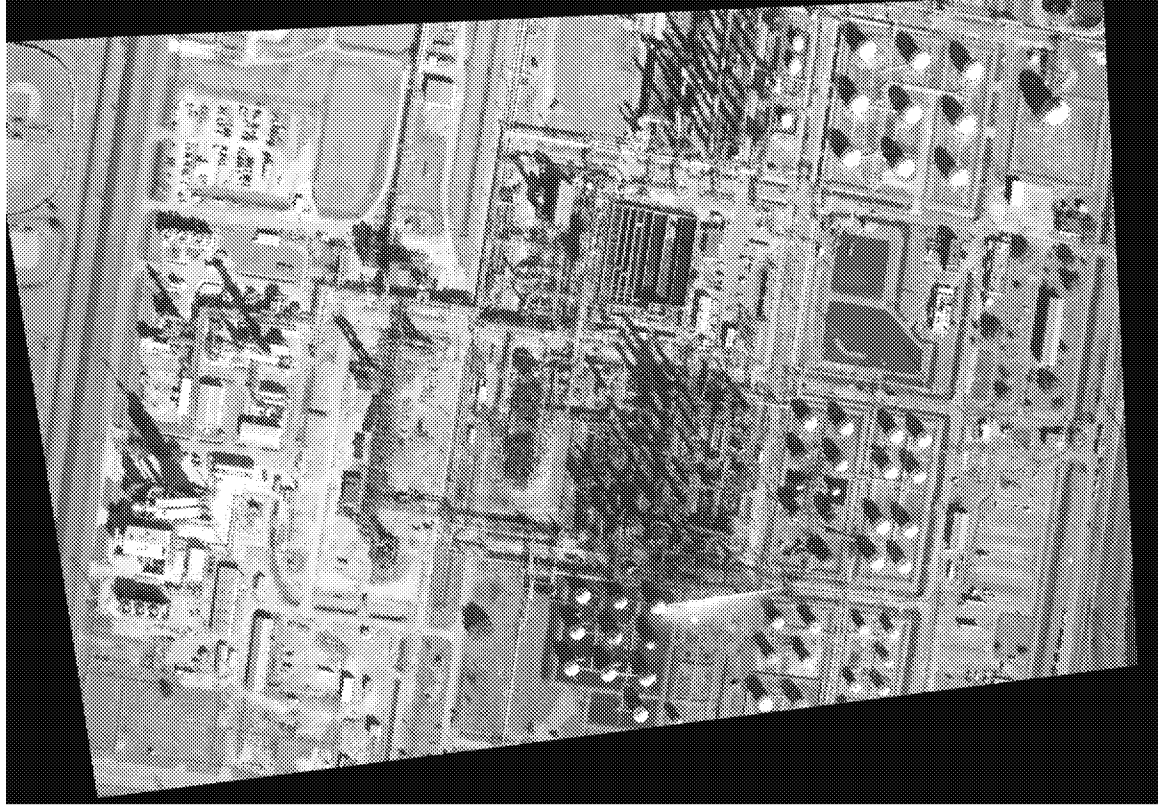
Figure 5: Aerial Image, Flight 14, Run 6, South 4 Group Fire.

A full set of high resolution aerial digital photography were collected as part of the flight. Figure 5 shows a representative image collected as part of each pass. Smoke is not evident in the image and only one water cannon can be observed being directed on the spherical tank south of the unit. The oblique image in Figure 6 shows a detail of the cannon use on the spherical tank.

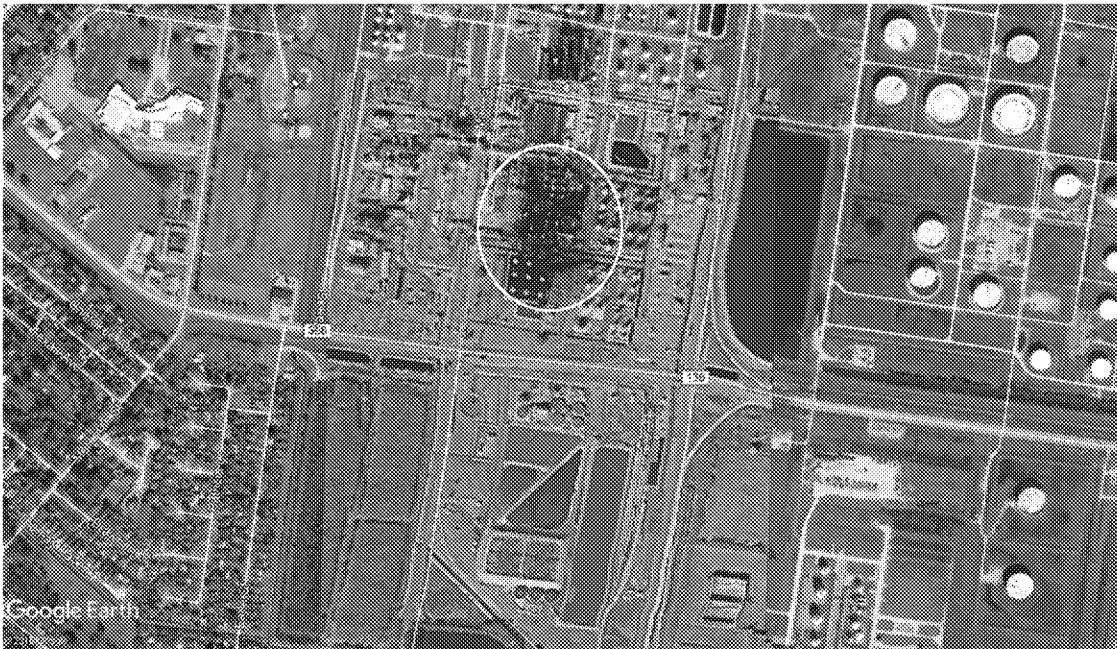
Figure 8: -- 3 band IR image, Flight 15, Run 2, South 4 Group Fire

A total of 1 test and 8 data collection passes were made in the proximity of the fire and an infrared line scanner image was generated for each pass. Figure 8 shows a 3-band infrared image obtained from data collected for Run 2. Examination of the image shows no significant elevated thermal locations on this collection pass. The white signatures seen on the tanks and metal structures are due to solar heating. No chemical plume was observed in the frame. Figure 9 shows a close-up of the process unit collected on Run 5. The most significant signature is that of the water spray and the cooling effect for the entire process unit. It should be noted that the water spray on the spherical tank has cooled to the tank to the same approximate temperature as the water. To check for possible oil sheen presence on the Naches River, ASPECT was flown along the waterway leading into the river. Figure 10 shows an IR image of the waterway/river confluence with no signature of oil sheen.

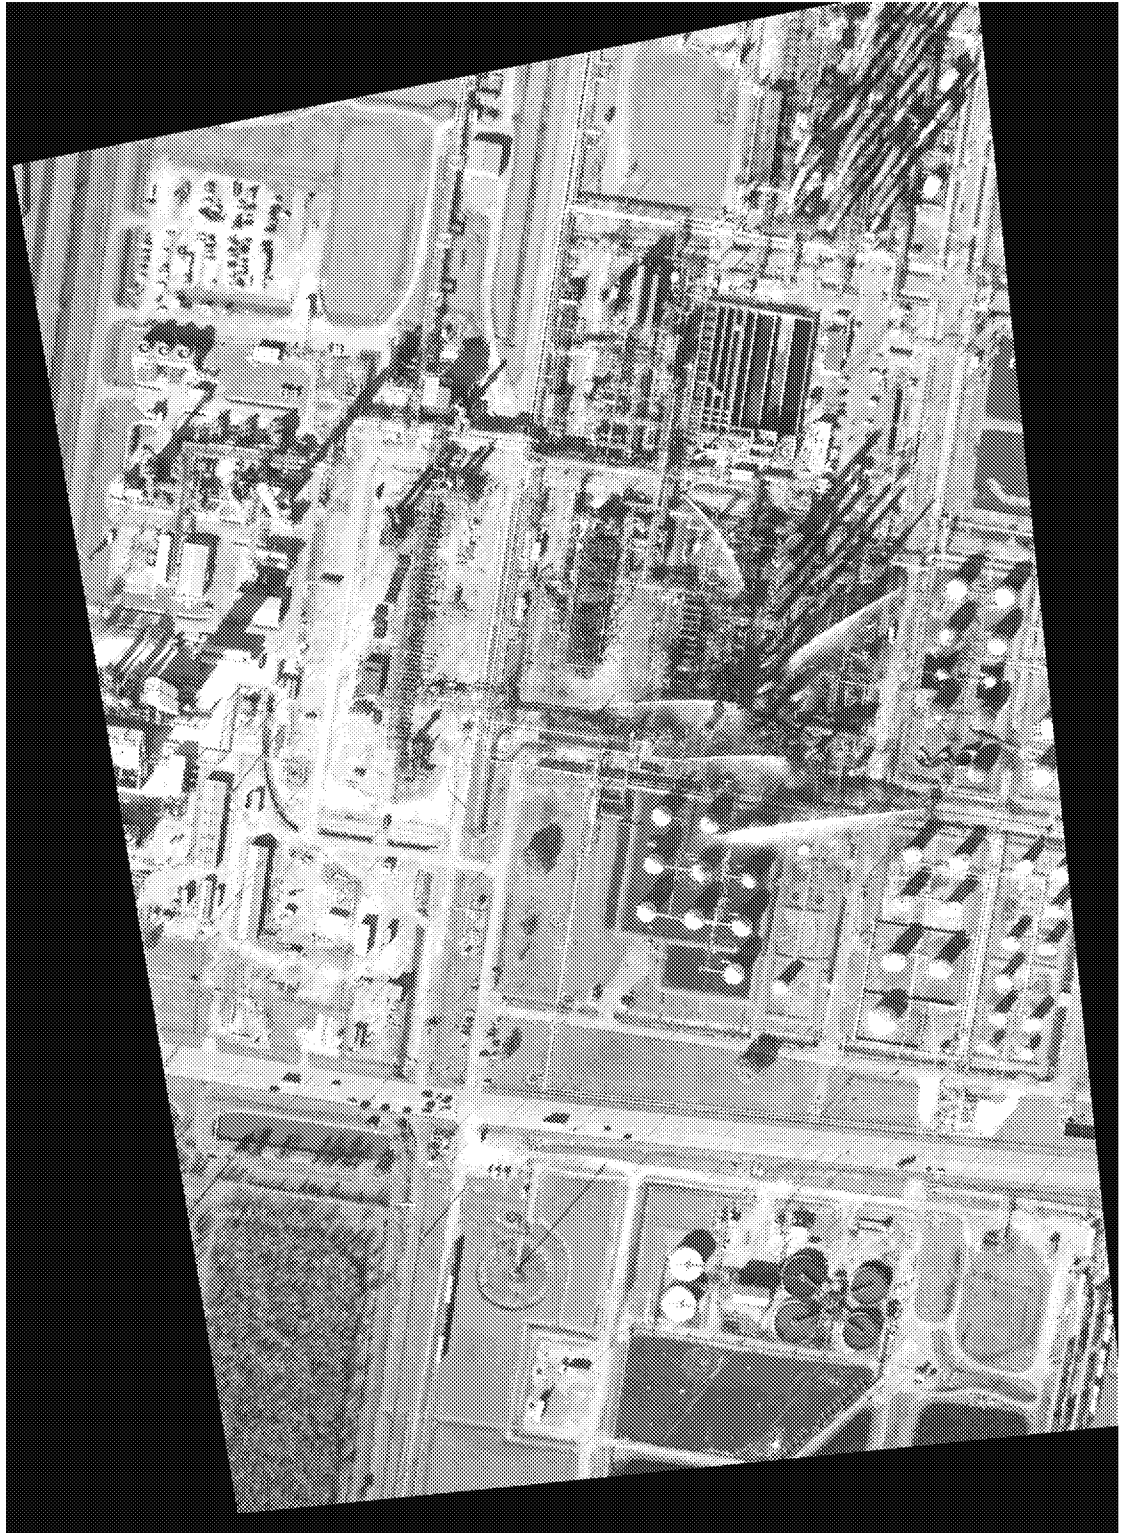
Figure 11: Aerial Image of the South 4Group Fire, Flight 15

A full set of high resolution aerial digital photography were collected as part of the flight. Figure 11 shows a representative image collected as part of each pass. Visible data mirrors that of the IR in that no smoke can be seen being emitted from the facility. At the time of the visible collection, in a similar fashion as the morning flight no smoke was observed being emitted from the site. Oblique imagery does show that water cannons continue to be used to flood the process unit (figure 12).
